SERVICE BULLETIN # 1005

SUBJECT Handle Frame Strengthening

MODEL 49 & 77 DATE 10-10-57

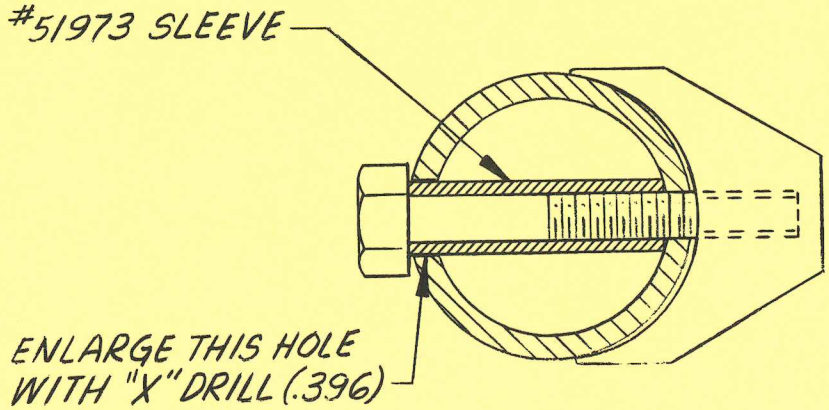
It has been discovered that the saw frame, part number 28561A, was crushing as the screws which attach it to the gear case were tightened. This crushing, in turn, caused the gear case mounting to fail. As a measure to correct this condition, a spacer sleeve, part number 51973, has been put into the screw holes to bear the stress of the tightened screws.

These spacer sleeves, part number 51973, are available for use in saws which have already left the factory without them. To install the spacer sleeve, the outside screw holes at the bottom of the frame must be enlarged to .396 of an inch, using a size "X" drill.
