SERVICE BULLETIN #1062

MODEL **S44**, S44A, S55, S55A DATE 7/9/59

SUBJECT **CRANKSHAFT IDENTIFICATION**

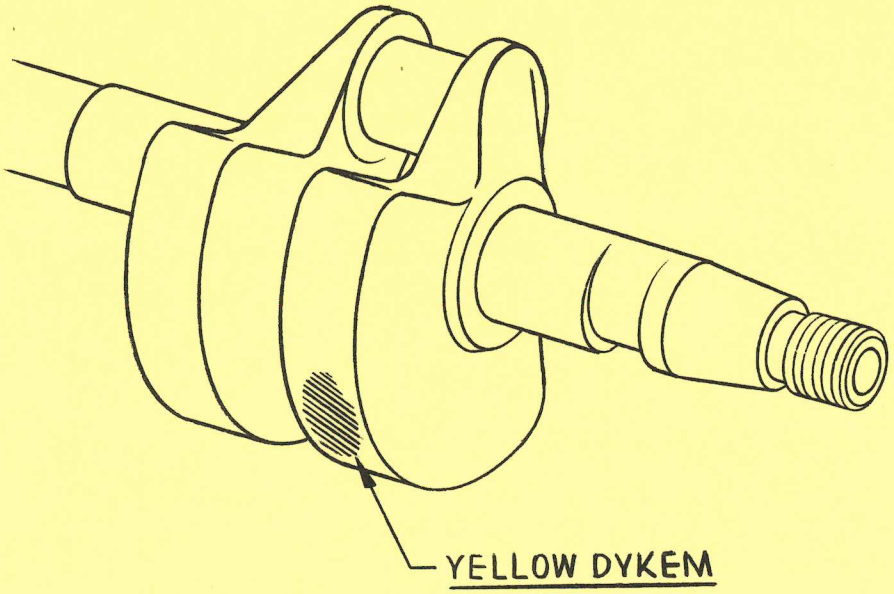
The crankshaft, P/N 55005 (used on Models S44 and S55), and the crankshaft, P/N 55257 (used on Models S44A and S55A), are similar in appearance. Because of this similarity, the wrong crankshaft may be installed in an engine unintentionally.

To avoid any mix-up between these two crankshafts and to provide a quick means of identification, a large spot of yellow dykem is now put on the counterweight area of the 55257 crankshaft.
