SERVICE BULLETIN # 1073

SUBJECT FUEL TANK VENT TUBE

MODEL 1-70, 1-80 DATE 10-1-59

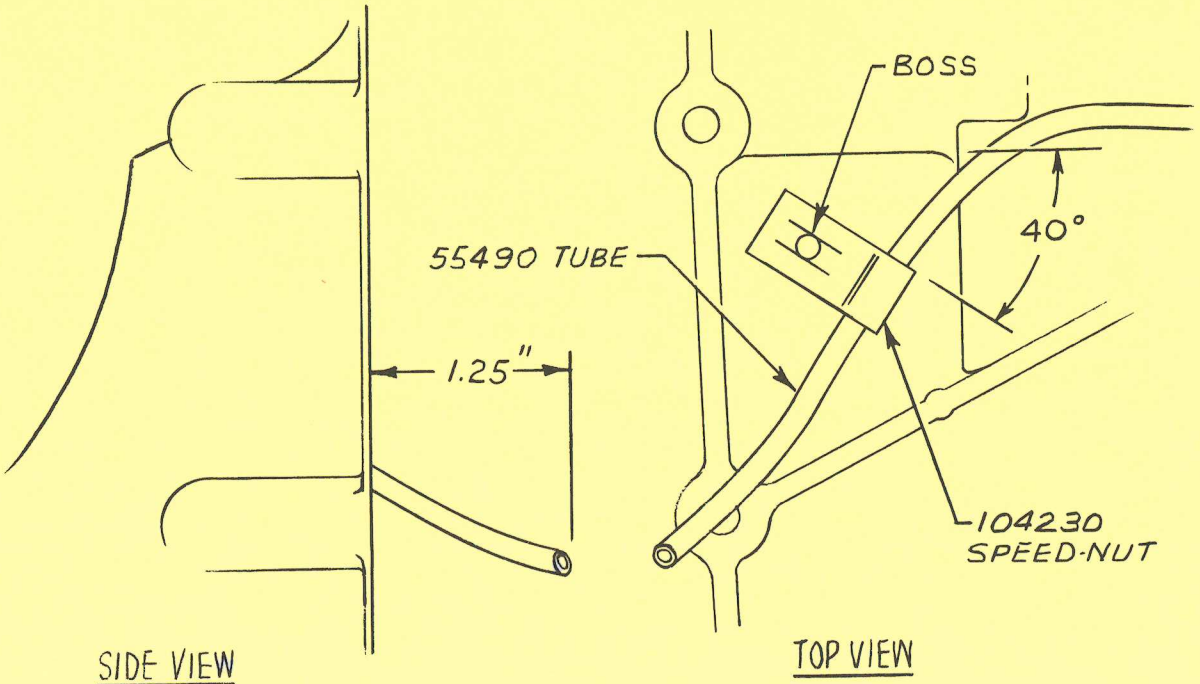
There have been reports that the fuel tank vent tube, P/N 55490, which is a component part of the fuel tank bottom assembly, P/N 55499, is being damaged or broken in parts order shipments enroute from the factory. In each case, the damage has been due to the upright position of the vent tube which is fastened securely in place by the speednut, P/N 104230.

1. Place the vent tube in position in fuel tank bottom as shown in illustration below.

2. Measure the length of the vent tube that extends beyond the casting edge of the fuel tank bottom (see illustration below). It should be 1-1/4 inch in length.

3. Press the speednut on th e boss in the fuel tank bottom. Make sure the speednut holds the vent tube firmly in place.
