McCULLOCH

SERVICE BULLETIN #1076

MODEL 1-80

SUBJECT CORRECT CLUTCH ROTOR REPLACEMENT

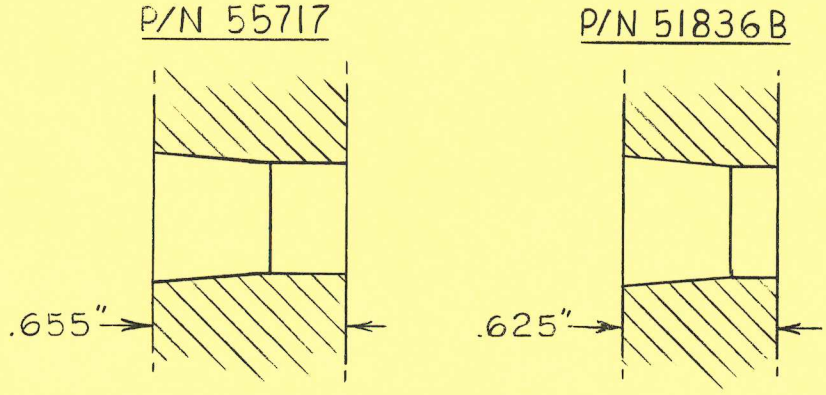
The internal taper difference between the new 55717 and the earlier 51836B assemblies is too great and serious clutch damage will result if the 51836B rotor and pawl assembly is installed on Model 1-80 engines.

When replacement of the Clutch Rotor and Pawl Assembly, P/N 55717, is required on Model 1-80 saw engines, always install a new P/N 55717 Clutch Rotor and Pawl Assembly. Do not replace P/N 55717 with the earlier clutch rotor and pawl assembly, P/N 51836B (used only on 55 series engines).
