McCULLOCH

SERVICE BULLETIN # 1081

MODEL 1-70

SUBJECT: CHAIN OIL LEAKAGE FROM BAR MOUNT INTERFERENCE

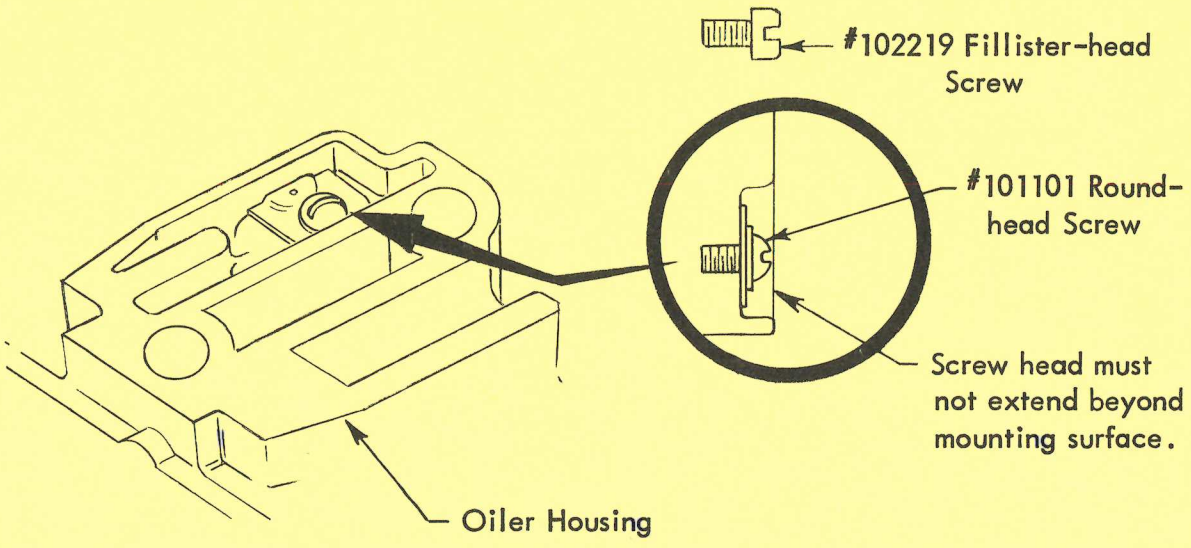
Because of accumulated tolerances, the fillister head screw may extend beyond the surface level of the mounting pad and prevent correct mounting of the bar on the mounting pad. This will permit oil to leak between the bar and oiler housing, will prevent proper chain lubrication, and cause excessive chain wear. Replacement of the fillister head screw with the round head screw will correct the oil leakage.

If chain oil leakage occurs between the bar and the bar mounting pad on the chain oiler housing, replace the original fillister head screw, P/N 102219, 8-32 x 1/4, with a round head screw, P/N 101101, 8-32 x 1/4.

NOTE: As a preventative measure, check all Model 1-70 engines and all Oiler Housing Assemblies, P/N 51938, in your stock and install the round head screw if required.
