McCULLOCH

SERVICE BULLETIN #1119

MODEL 99

SUBJECT SHIM (TRANSMISSION TO CRANKCASE COVER)

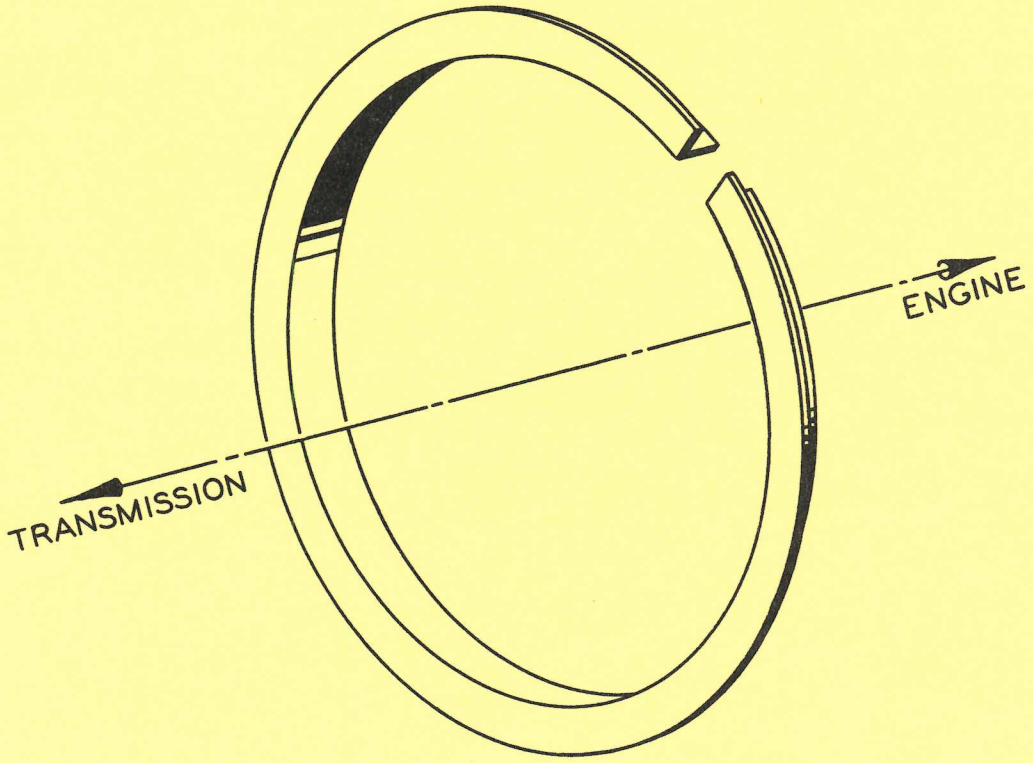
To provide longer service life for the clutch assembly, install a Transmission Shim, P/N 24790, between the transmission assembly and the crankcase cover. The mating surfaces on the transmission assembly and the crankcase cover are subject to wear. If the mating surface wear becomes excessive, causing misalignment, cutting will be more difficult and early clutch failure can result.

Installation of the Transmission Shim, P/N 24790, will correct the alignment of the two mating surfaces if they are loose or worn.
