McCULLOCH

SERVICE BULLETIN #1156

SUBJECT STARTER ASSEMBLY, P/N 55129C

MODEL 1-62, 1-82, 1-85 DATE 1-16-62

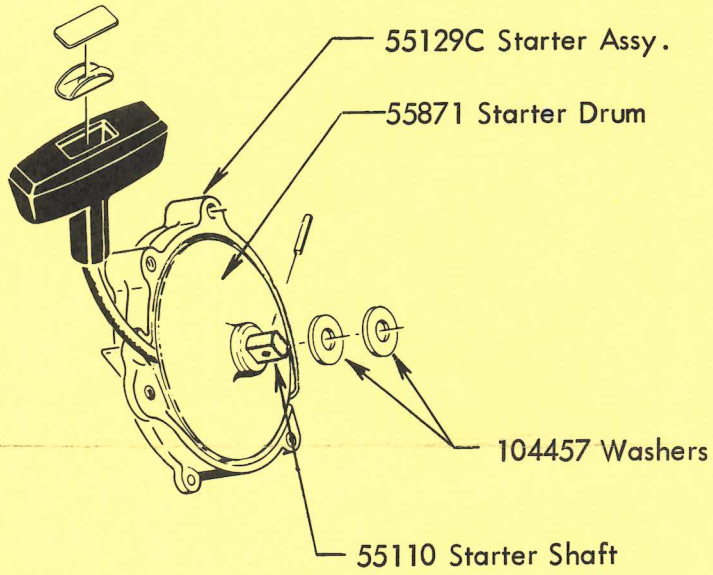
Due to an inadvertent shift in dimensional tolerances between the Starter Drum, P/N 55871, and the Starter Shaft, P/N 55110, a limited quantity of Starter Assemblies, P/N 55129C, were assembled with a second Washer, P/N 104457, installed under the roll pin.

If the second washer is not in place, the ratchet end of the starter shaft may possibly bottom on the clutch rotor assembly.

Thus, when servicing the starter assembly, carefully check the number of washers used and replace accordingly.
