SERVICE BULLETIN # 1165

SUBJECT CRANKCASE COVER ASSEMBLIES, P/N 57126 AND P/N 57126A

MODEL MC-1, MC-2, MC-7, 1-42, 1-45, 1-52, 1-62 DATE 3/19/62

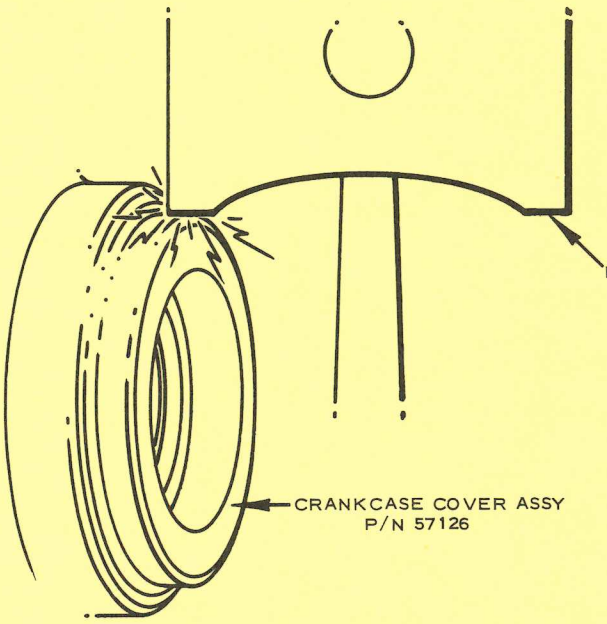
FIGURE 1

The MC-2 and MC-7 engines have a longer stroke than the other models listed. At the bottom of the stroke the piston skirt will strike on the bearing boss of the Crankcase Cover Assembly, P/N 57126 (Figure 1). As a result piston breakage and other damage to an MC-2 or MC-7 kart engine will occur.

Crankcase Cover Assembly, P/N 57126, listed in the Illustrated Parts List as the service replacement for the MC-1, MC-2, MC-7, 1-42, 1-45, 1-52, 1-62 model engines, MUST NOT be used on the MC-2 or MC-7 kart engines!
