McCULLOCH

SERVICE BULLETIN #1189

SUBJECT OCCASIONAL CAUSE OF A LEAKING REED VALVE

MODEL 1-43, 1-46, 1-53, 1-63 DATE 8/2/62

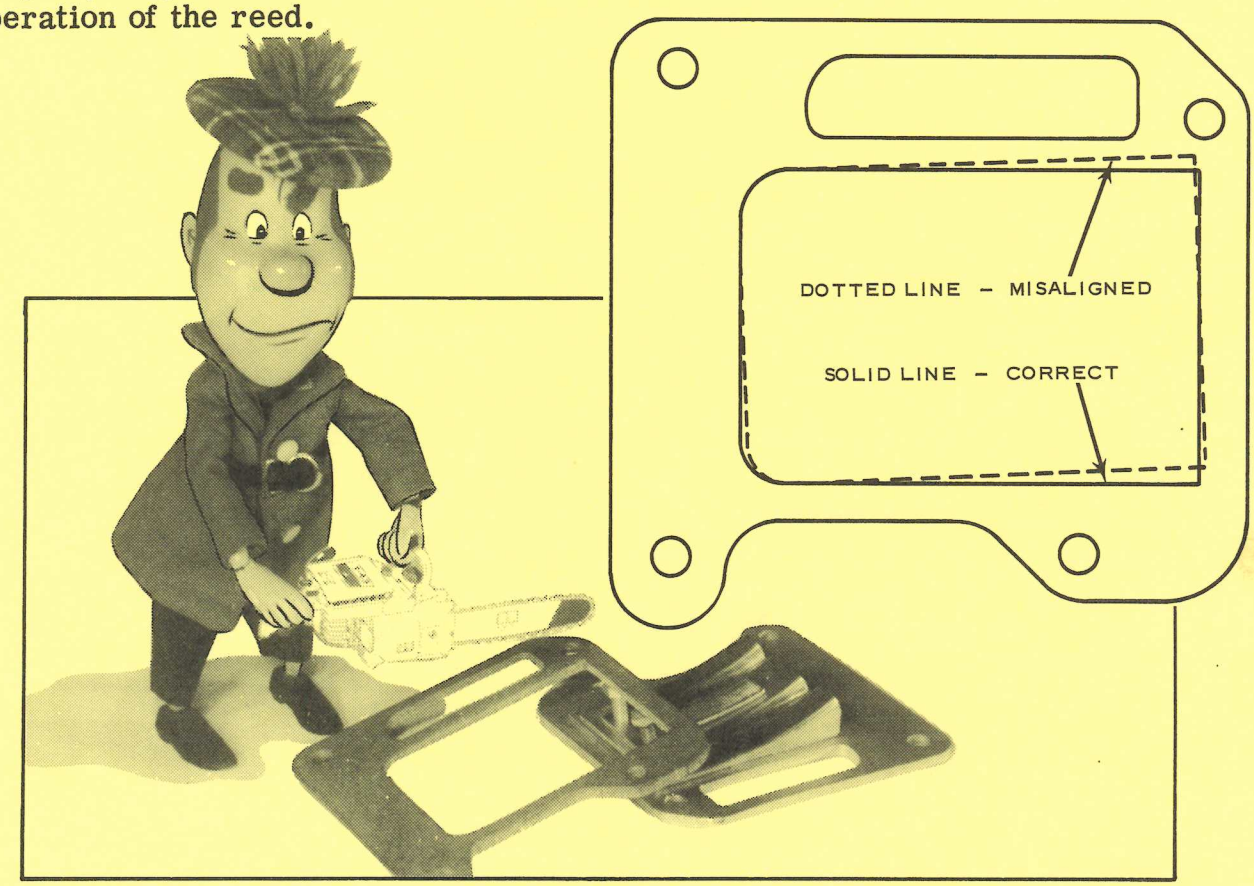
An occasional cause of a leaking reed valve can be failure to install the reed and its allied parts correctly. Should there be any interference between the parts, the reed may be forced aside from the central holes in the reed plate permitting leakage of fuel.

When installing the reed plate insulator, fuel deflector, reed, reed plate and airbox gasket, make sure that the central openings as well as the mounting holes, are properly aligned. Should there be interference between the fuel deflector and the central opening of the reed plate insulator so that the fuel deflector and reed are forced out of central alignment, shave or otherwise fit the central opening of the reed plate insulator so that the deflector can be aligned with the reed, reed plate and airbox gasket. When all these parts are properly aligned and correctly installed there will be no interference with the operation of the reed.
