McCULLOCH

SERVICE BULLETIN #1191

SUBJECT IMPROVING SWITCH BUTTON ACTION

MODEL 1-46, 1-53 DATE 8/31/62

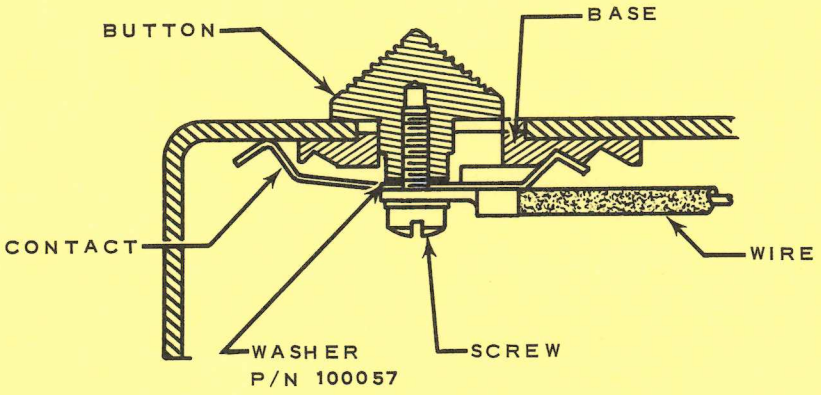
At the top of the fan housing where the ignition switch is mounted on Model 1-46 and 1-53 engines, metal thickness and switch contact spring tension may combine to make the switch button difficult to move. This difficulty has been eliminated on current production models by inserting a Washer, P/N 100057, between the button and the contact.

As shown in the drawing below, place the Washer, P/N 100057, against the end of the switch button, then replace the switch contact, stop-switch wire assembly, and the retaining screw in the same order in which they were removed. Replace the fan housing.
