McCULLOCH CORPORATION
SERVICE BULLETIN

1555

MODEL: Super 250, Super 550

SUBJECT: CLUTCH GUARD CLEARANCE

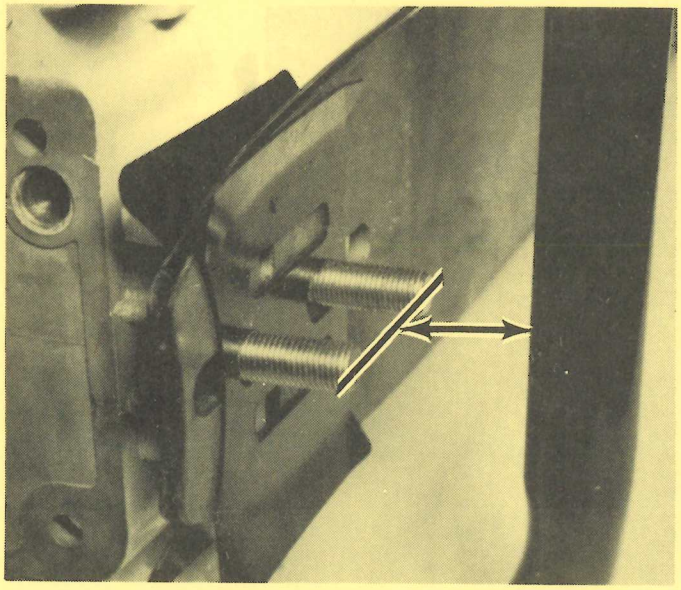
Lower frame screw holes are slightly mis-aligned in some of the frames used on Super 250 and 550 saws. This results in the outer frame arm being too close to the ends of the bar mounting bolts for removal or installation of the guard. See Figure 1.
