McCULLOCH SERVICE BULLETIN

NO. 1598

MODEL Mini-Mac 25, 30, and 35 DATE February 20, 1976

SUBJECT Ignition Coil Ground Wire.

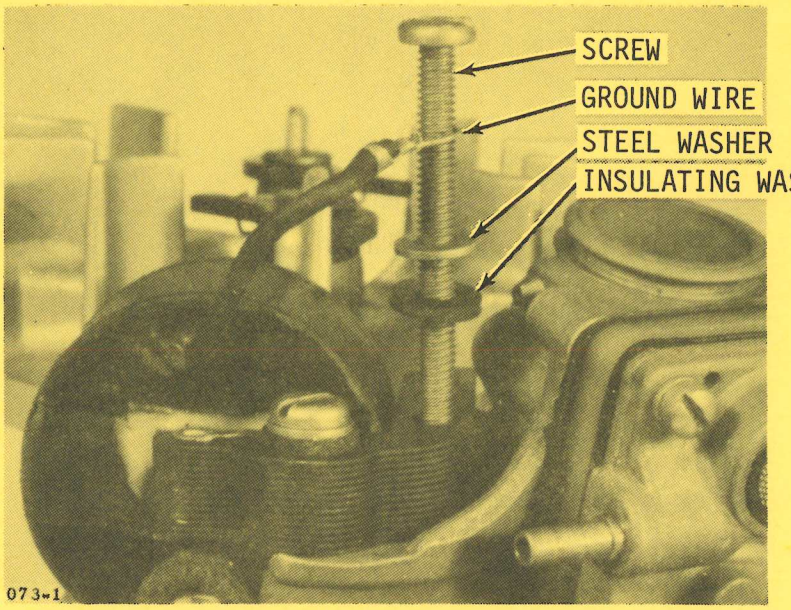
Reports about erratic engine performance have, in some cases, been traced to a poor ground for the ignition coil ground wire. This problem has shown up only on those units which have carburetor insulating sleeves and an insulating washer on the coil screws. Unless the wire is assembled so there is metal to metal contact between the screw and wire there is the possibility of a poor ground.

We recommend that this ground wire be assembled as shown in the illustration below to assure a positive ground.
