McCULLOCH

SERVICE BULLETIN

NO. 1628

SUBJECT Proper Starter Alignment

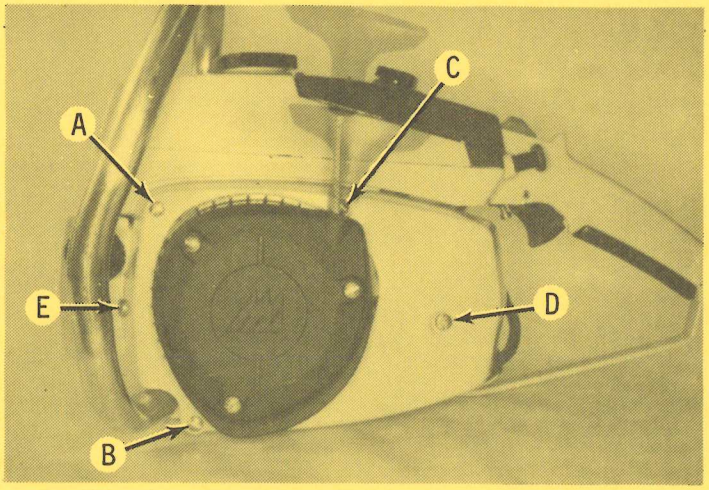
Starter engagement problems in Mac 10-10, Pro Mac 10-10, PM 55, and 7-10A models have been traced to misalignment of starter shaft with starter pawls. To correct this, the following sequence for tightening fan housing fasteners has been established:

Any deviation from this sequence will pull starter shaft out of alignment with starter pawls.

1) Tighten three (3) special screws around starter assembly; top front (A) first, bottom front (B) second, and top rear (C) third.

2) Tighten rear fan housing screw (D).

3) Front screw (E) should be tightened last.

A slight dimensional change has been made to the crankcase boss to aid in front screw alignment.

NOTE: For rear screw, the fan housing hole should align with the special stud. If not, file a slot in fan housing hole until proper alignment is achieved.
