SERVICE BULLETIN # 1012

SUBJECT Governor Wire Installation

MODEL **Attachments** DATE 2-5-58

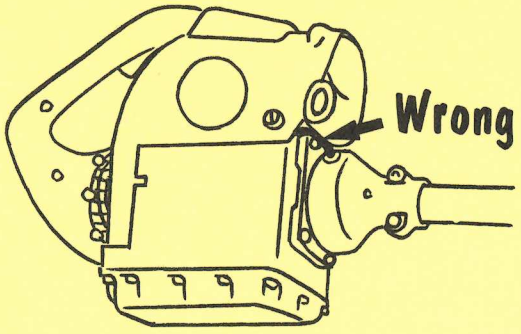
When the governor was first introduced on the Brushcutter Attachment, its wire assembly, part number 52149, was assembled so that it passed over the head of the housing retaining screw, part number 101982, on the side closest to the muffler, part number 36932.

It was discovered that heat from the muffler quickly burned through the insulation on the wire causing grounding of the wire and stopping of the engine.

To correct this condition, the governor wire is now passed under the retaining screw head on the side away from the muffler. It is suggested that any Brushcutter attachments received with the governor wire passing over the retaining screw head should have this condition corrected.
