McCULLOCH SERVICE BULLETIN #1012A

MODEL BRUSHCUTTER DATE 7-25-58

SUBJECT: IMPROVEMENT OF GOVERNOR WIRE INSTALLATION

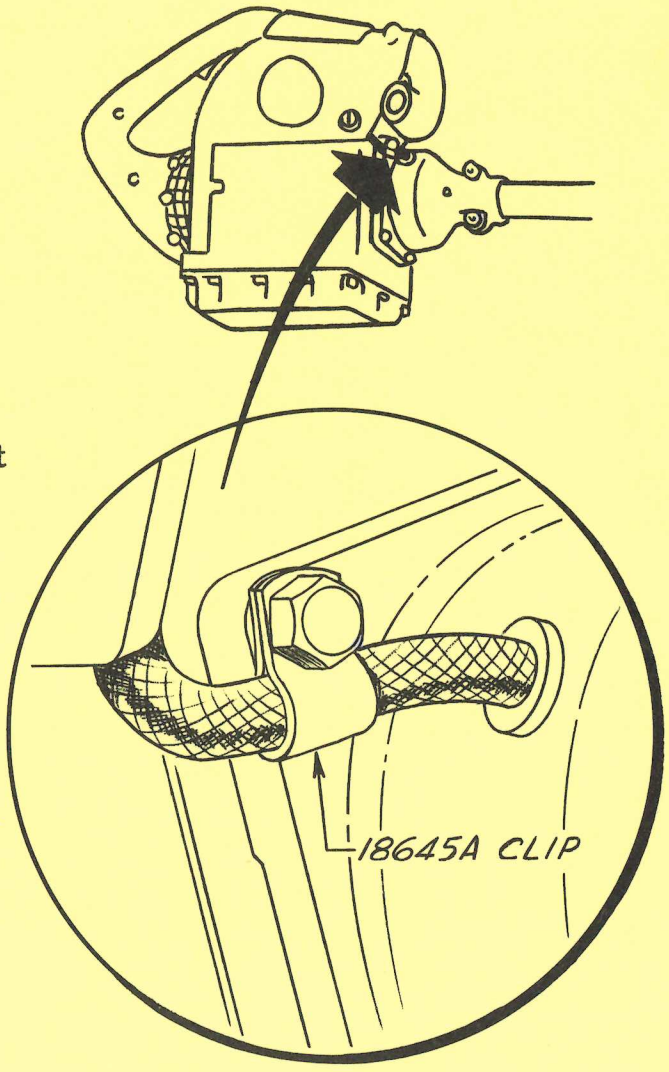
Service Bulletin #1012 described a method of preventing muffler heat from burning through the governor wire insulation. In some instances, however, this method is not successful.

Earl Pearson of Power Tools, Inc., in St. Paul, Minnesota, has suggested an improvement upon the technique described in Service Bulletin #1012. He suggests that a Clip, P/N 18645A, be attached to the right corner hold down screw of the transmission, and the governor wire passed through the clip. Use of the clip will eliminate any possibility of the wire slipping over the screw head and making contact with the hot muffler.
