McCULLOCH

SERVICE BULLETIN #1074

SUBJECT CLUTCH SHOE DAMAGE

MODEL 1-80, 55 Series DATE 9-22-59

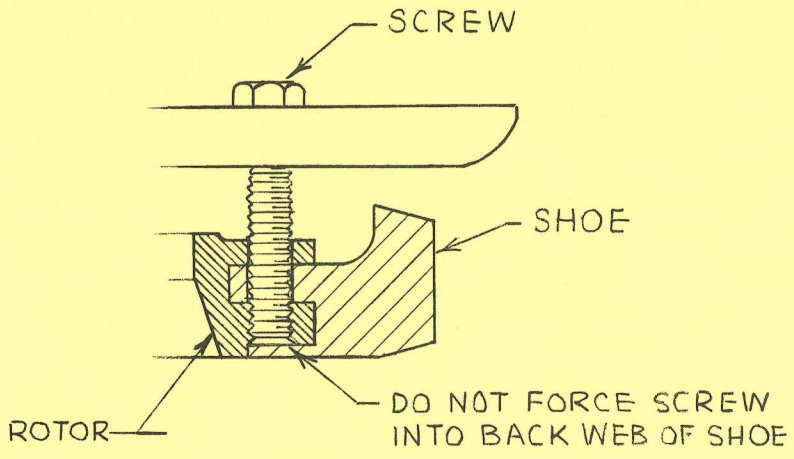
When using the clutch puller tool to remove the clutch assemblies which contain the new cast iron shoes, do not jam the clutch puller attaching screws against the cast iron shoes. If the screws are jammed against the cast iron shoes, the shoes may be damaged or broken.

To avoid jamming the clutch puller attaching screws, gently turn-in the screws until you feel them bottom against the clutch shoes. Then, back them off one full turn and remove the clutch assembly in the usual manner.
