McCULLOCH

SERVICE BULLETIN # 1094

MODEL 1-80, 1-60 DATE 2/4/60

SUBJECT NEW GEARCASE GASKET

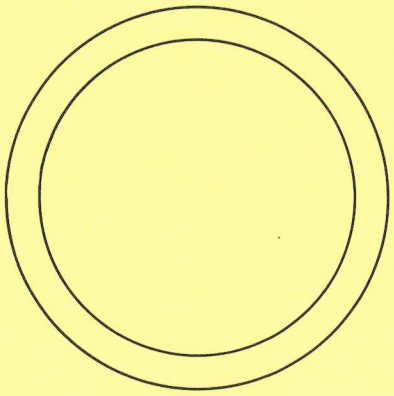
NEW 51635A GASKET

To prevent loosening of the transmission assemblies on Model 1-80 and 1-60 engines due to gasket shrinkage, a new, thin Gearcase Gasket, P/N 51635A, is available for service replacement. The new gasket replaces the thicker 51635 gasket.

The modified design of the new gasket permits metal-to-metal contact at the three bolt locations on the gearcase. It's thickness, .004 inch, is not sufficient to cause a dangerous stress across the mounting area when the bolts are tightened. The new gasket is of high rag content paper which provides an excellent seal and good compressive strength.
