McCULLOCH

SERVICE BULLETIN # 1112

SUBJECT NEW STEEL BREAKER BOX COVER

MODEL 1-71, 1-81, 1-81 HD DATE 11/1/60

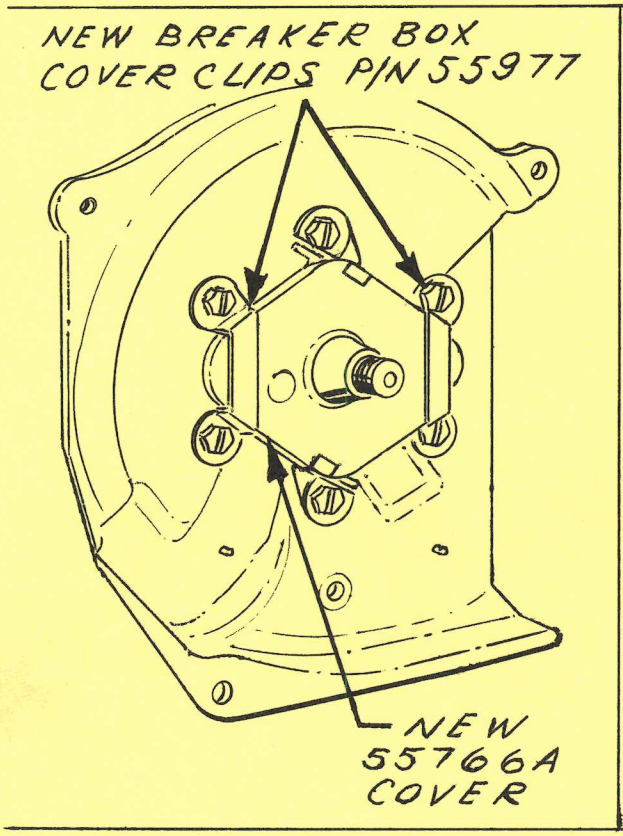
FIGURE 1

A new moisture - and dirt-proof Breaker Box Cover, P/N 55766A (shown in Figure 1 above), is available for service replacement on Model 1-71, 1-81, and 1-81 HD engines. The new steel cover replaces the earlier plastic cover, P/N 55766.

1. Remove the six retaining screws, four lockplates, two clamps, and the old breaker box cover from the crankcase cover assembly.

2. Put the new Breaker Box Cover over the breaker points and secure with two new Breaker Box Cover Clips, P/N 55977, and four of the original retaining screws just removed (see Figure 1).

3. Reinstall the two clamps with the two remaining screws.
