# McCULLOCH CORPORATION
# SERVICE BULLETIN

1522

MODEL: Mini Mac 6,® 6A June 12, 1972

SUBJECT: OILER ROD AND PISTON MISALIGNMENT

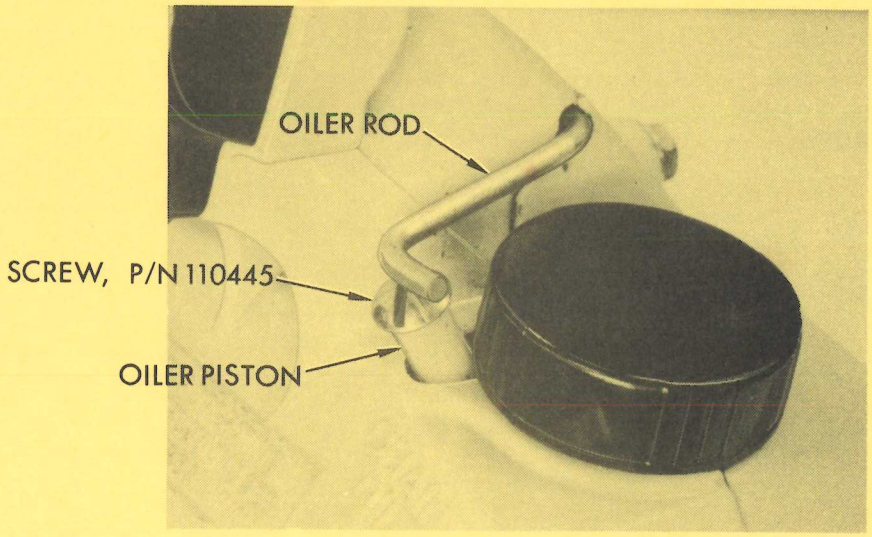
It has been reported that the manual oiler rod on Mini-Mac 6 or 6A saws can slip off the upper end of the manual oiler piston as the oiler rod becomes worn.

A simple cure for this problem is the installation of a Screw, P/N 110445, into the rod end of the piston as shown. The screw head, being larger in diameter than the oiler piston provides a larger contact surface for the oiler rod.
